## Parks & Public Works Committee Agenda Item Report

**SUBJECT:** Mt. Baldhead Revegetation

# PROPOSAL FOR CONSERVATION SERVICES

# Tree Removal, Replacement, and Erosion Control Plan

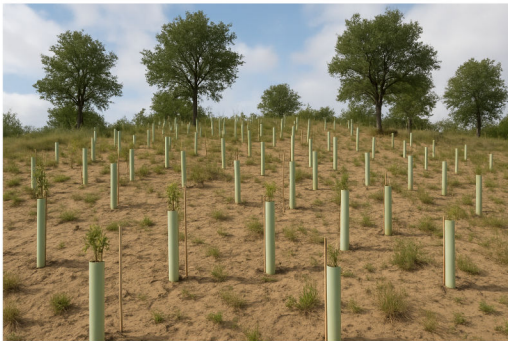
## INDIVIDUAL TREE PROTECTIONS

TREES WILL RECEIVE A 4' TREE TUBE FOLLOWING PLANTING TO DISCOURAGE HERBIVORY OF MERISTEMS AND DESTRUCTION OF PERIDERM. TUBES ALSO INCREASE HUMIDITY AROUND YOUNG TREE TO INCREASE SURVIVABILITY.

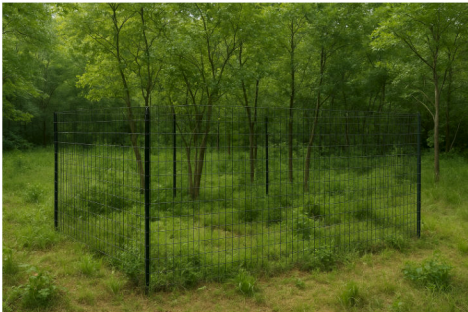
## DEER EXCLUSION ZONES

30'x30' AREAS WILL BE FENCED OFF TO PREVENT DEER AND ANTHROPOGENIC DISTURBANCE WHILE THE PLANT COMMUNITY DEVELOPS. EXCLUSION AREAS ARE STRATEGICALLY PLACED IN SPARSELY VEGETATED AREAS PRONE TO EROSION.
