## City Council Agenda Item Report

**SUBJECT:** Mt. Baldhead Revegetation

# Mount Baldhead Revegetation Project Charter

# Tree Removal, Replacement, and Erosion Control Plan

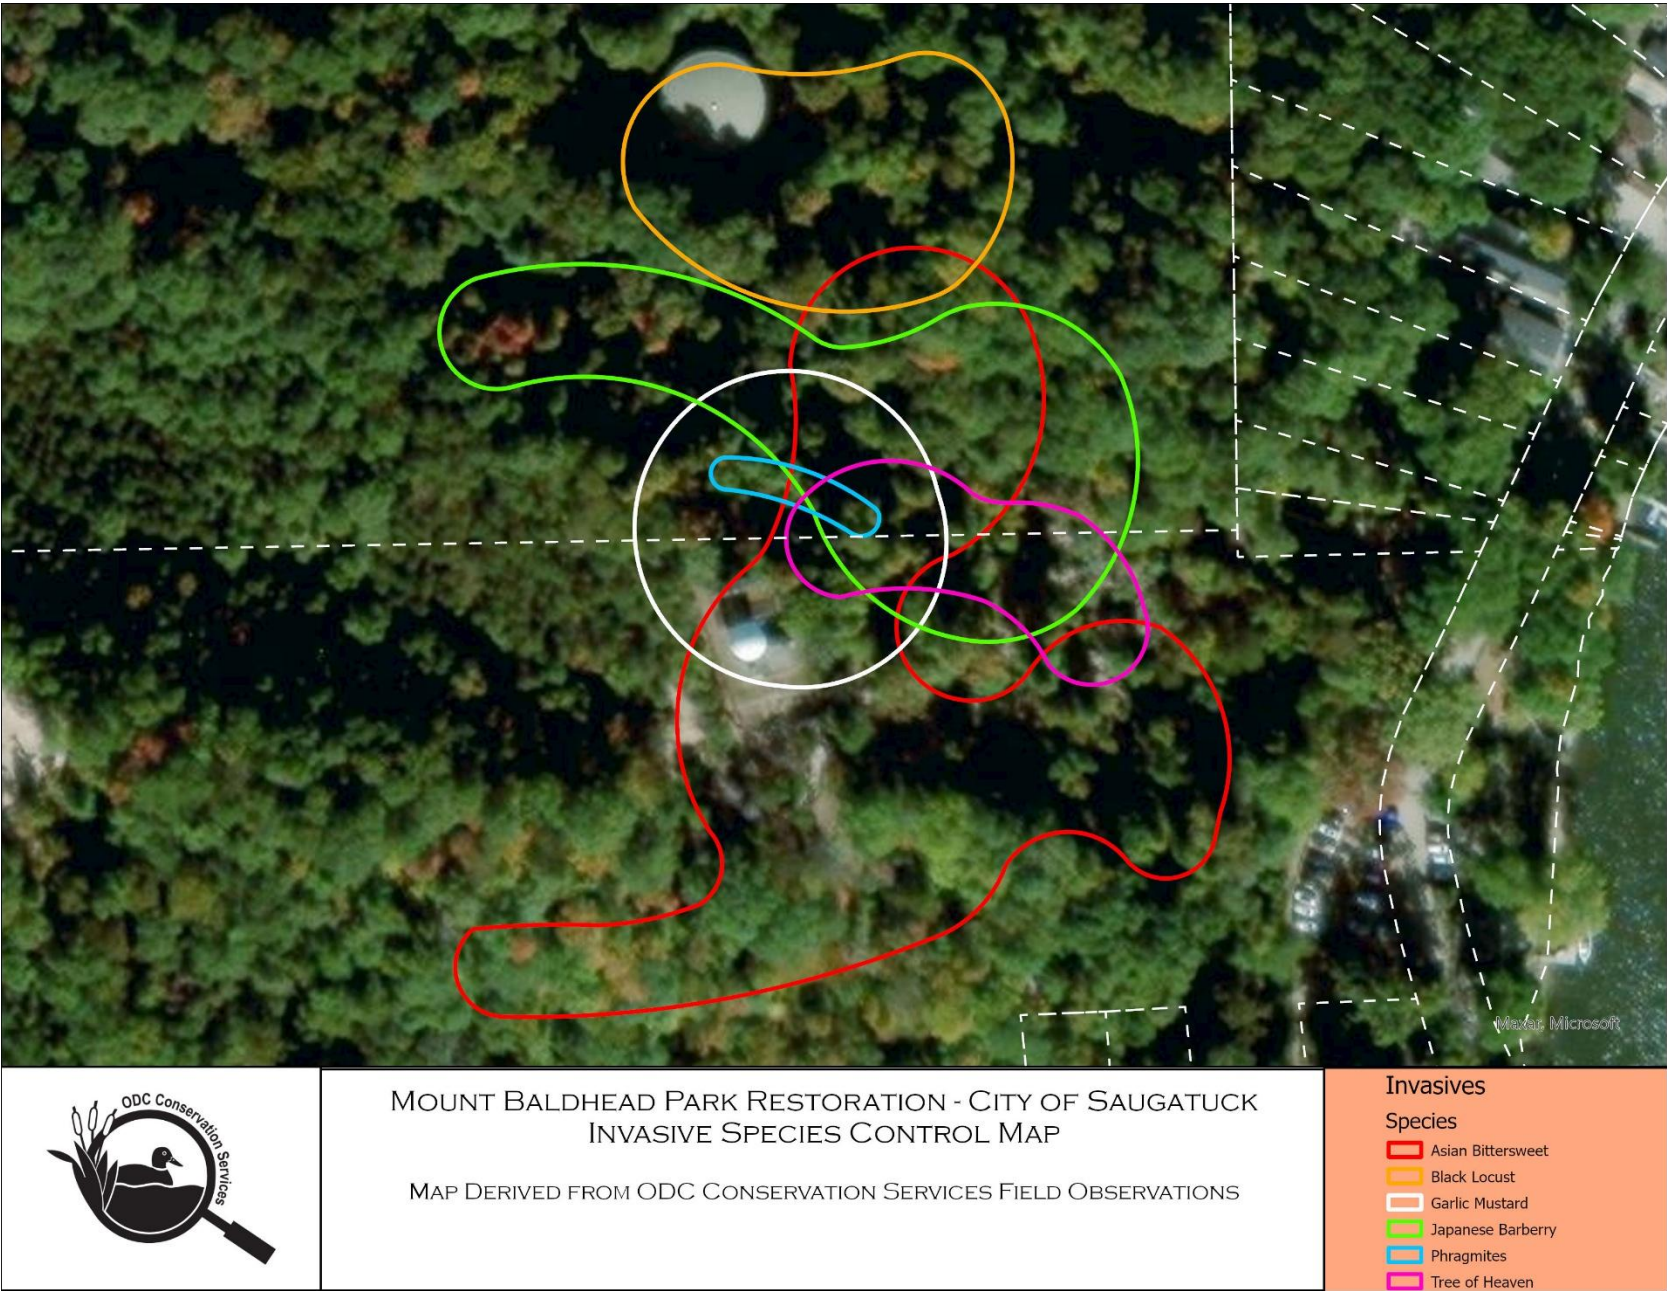
Appendix A: Map of Surveyed Invasive Species

- Several highly invasive species are present that threaten the integrity of the dune habitat, including: garlic mustard, multiflora rose, Asian bittersweet, Japanese barberry, tree-of-heaven, phragmites, and black locust.

### 1. Invasive Species Management (see Appendix A for map)

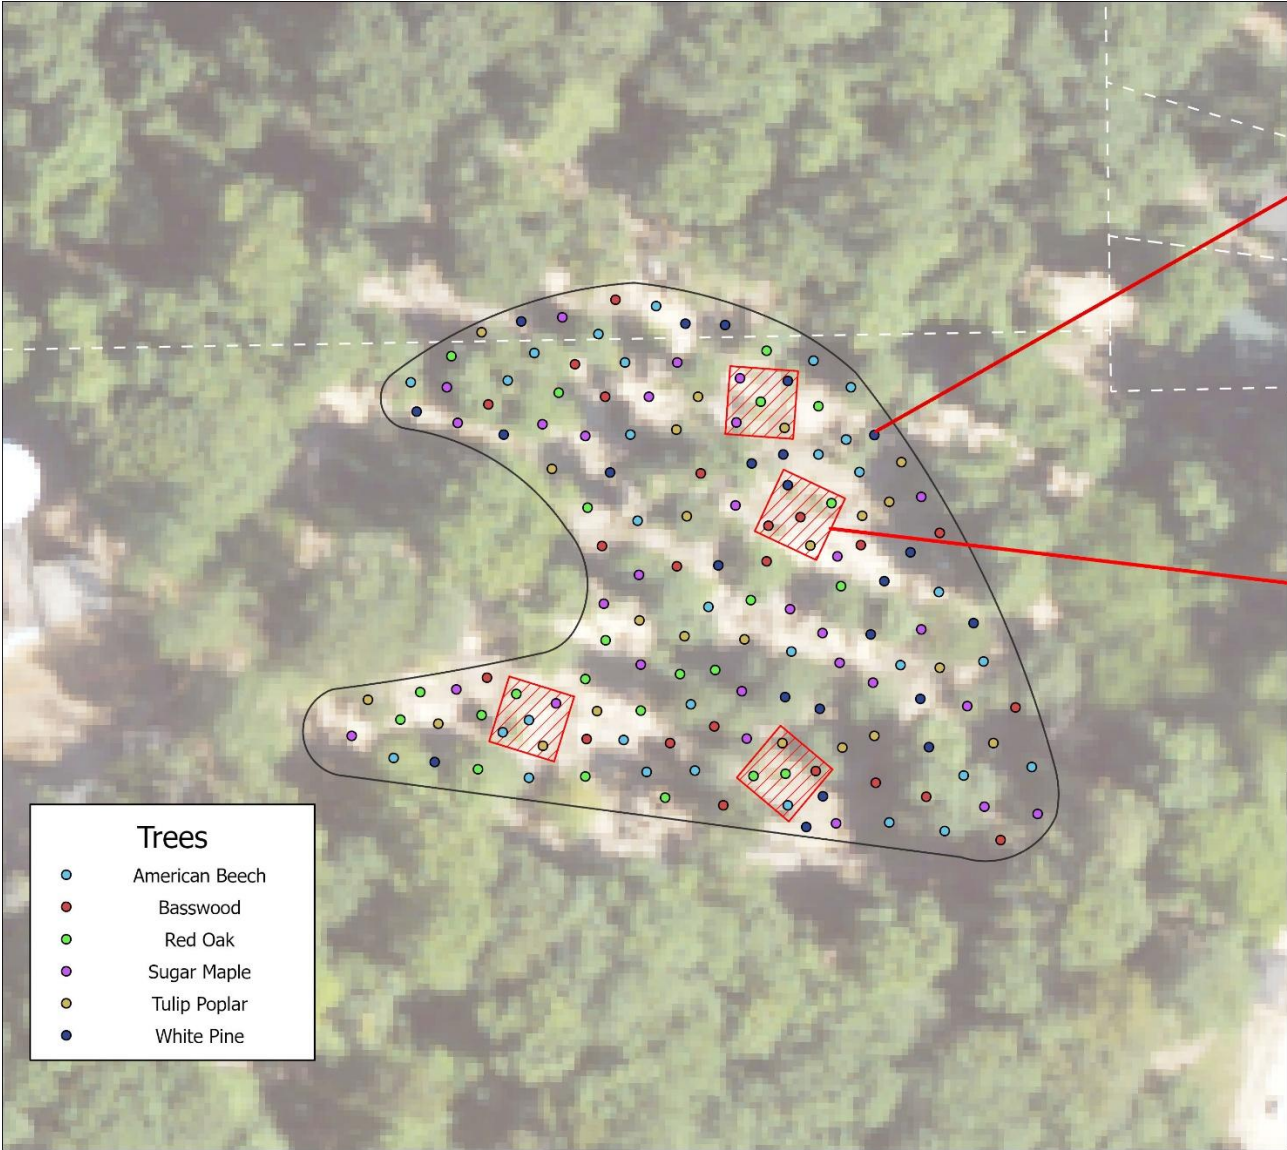
Appendix B: Replanting Zones and Tree Exclusion Areas

TREES WILL RECEIVE A 4' TREE TUBE FOLLOWING PLANTING TO DISCOURAGE HERBIVORY OF MERISTEMS AND DESTRUCTION OF PERIDERM. TUBES ALSO INCREASE HUMIDITY AROUND YOUNG TREE TO INCREASE SURVIVABILITY.

30'x30' AREAS WILL BE FENCED OFF TO PREVENT DEER AND ANTHROPOGENIC DISTURBANCE WHILE THE PLANT COMMUNITY DEVELOPS. EXCLUSION AREAS ARE STRATEGICALLY PLACED IN SPARSELY VEGETATED AREAS PRONE TO EROSION.

- Approximately **500** native plants will be installed throughout the unit, including, bare-root, 1-3 gallon, and 4" plugs.
  - Protective exclusion measures such as tree tubes and four 900 ft<sup>2</sup> sections of 6'-tall exclusion fencing will be implemented where applicable to prevent herbivory and physical damage to developing plantings (See *Appendix B* for layout).

- Informational signage will be installed in high-traffic and erosion-prone areas to encourage public awareness, limit off-trail usage, and protect restoration efforts (See *Appendix B* for examples).

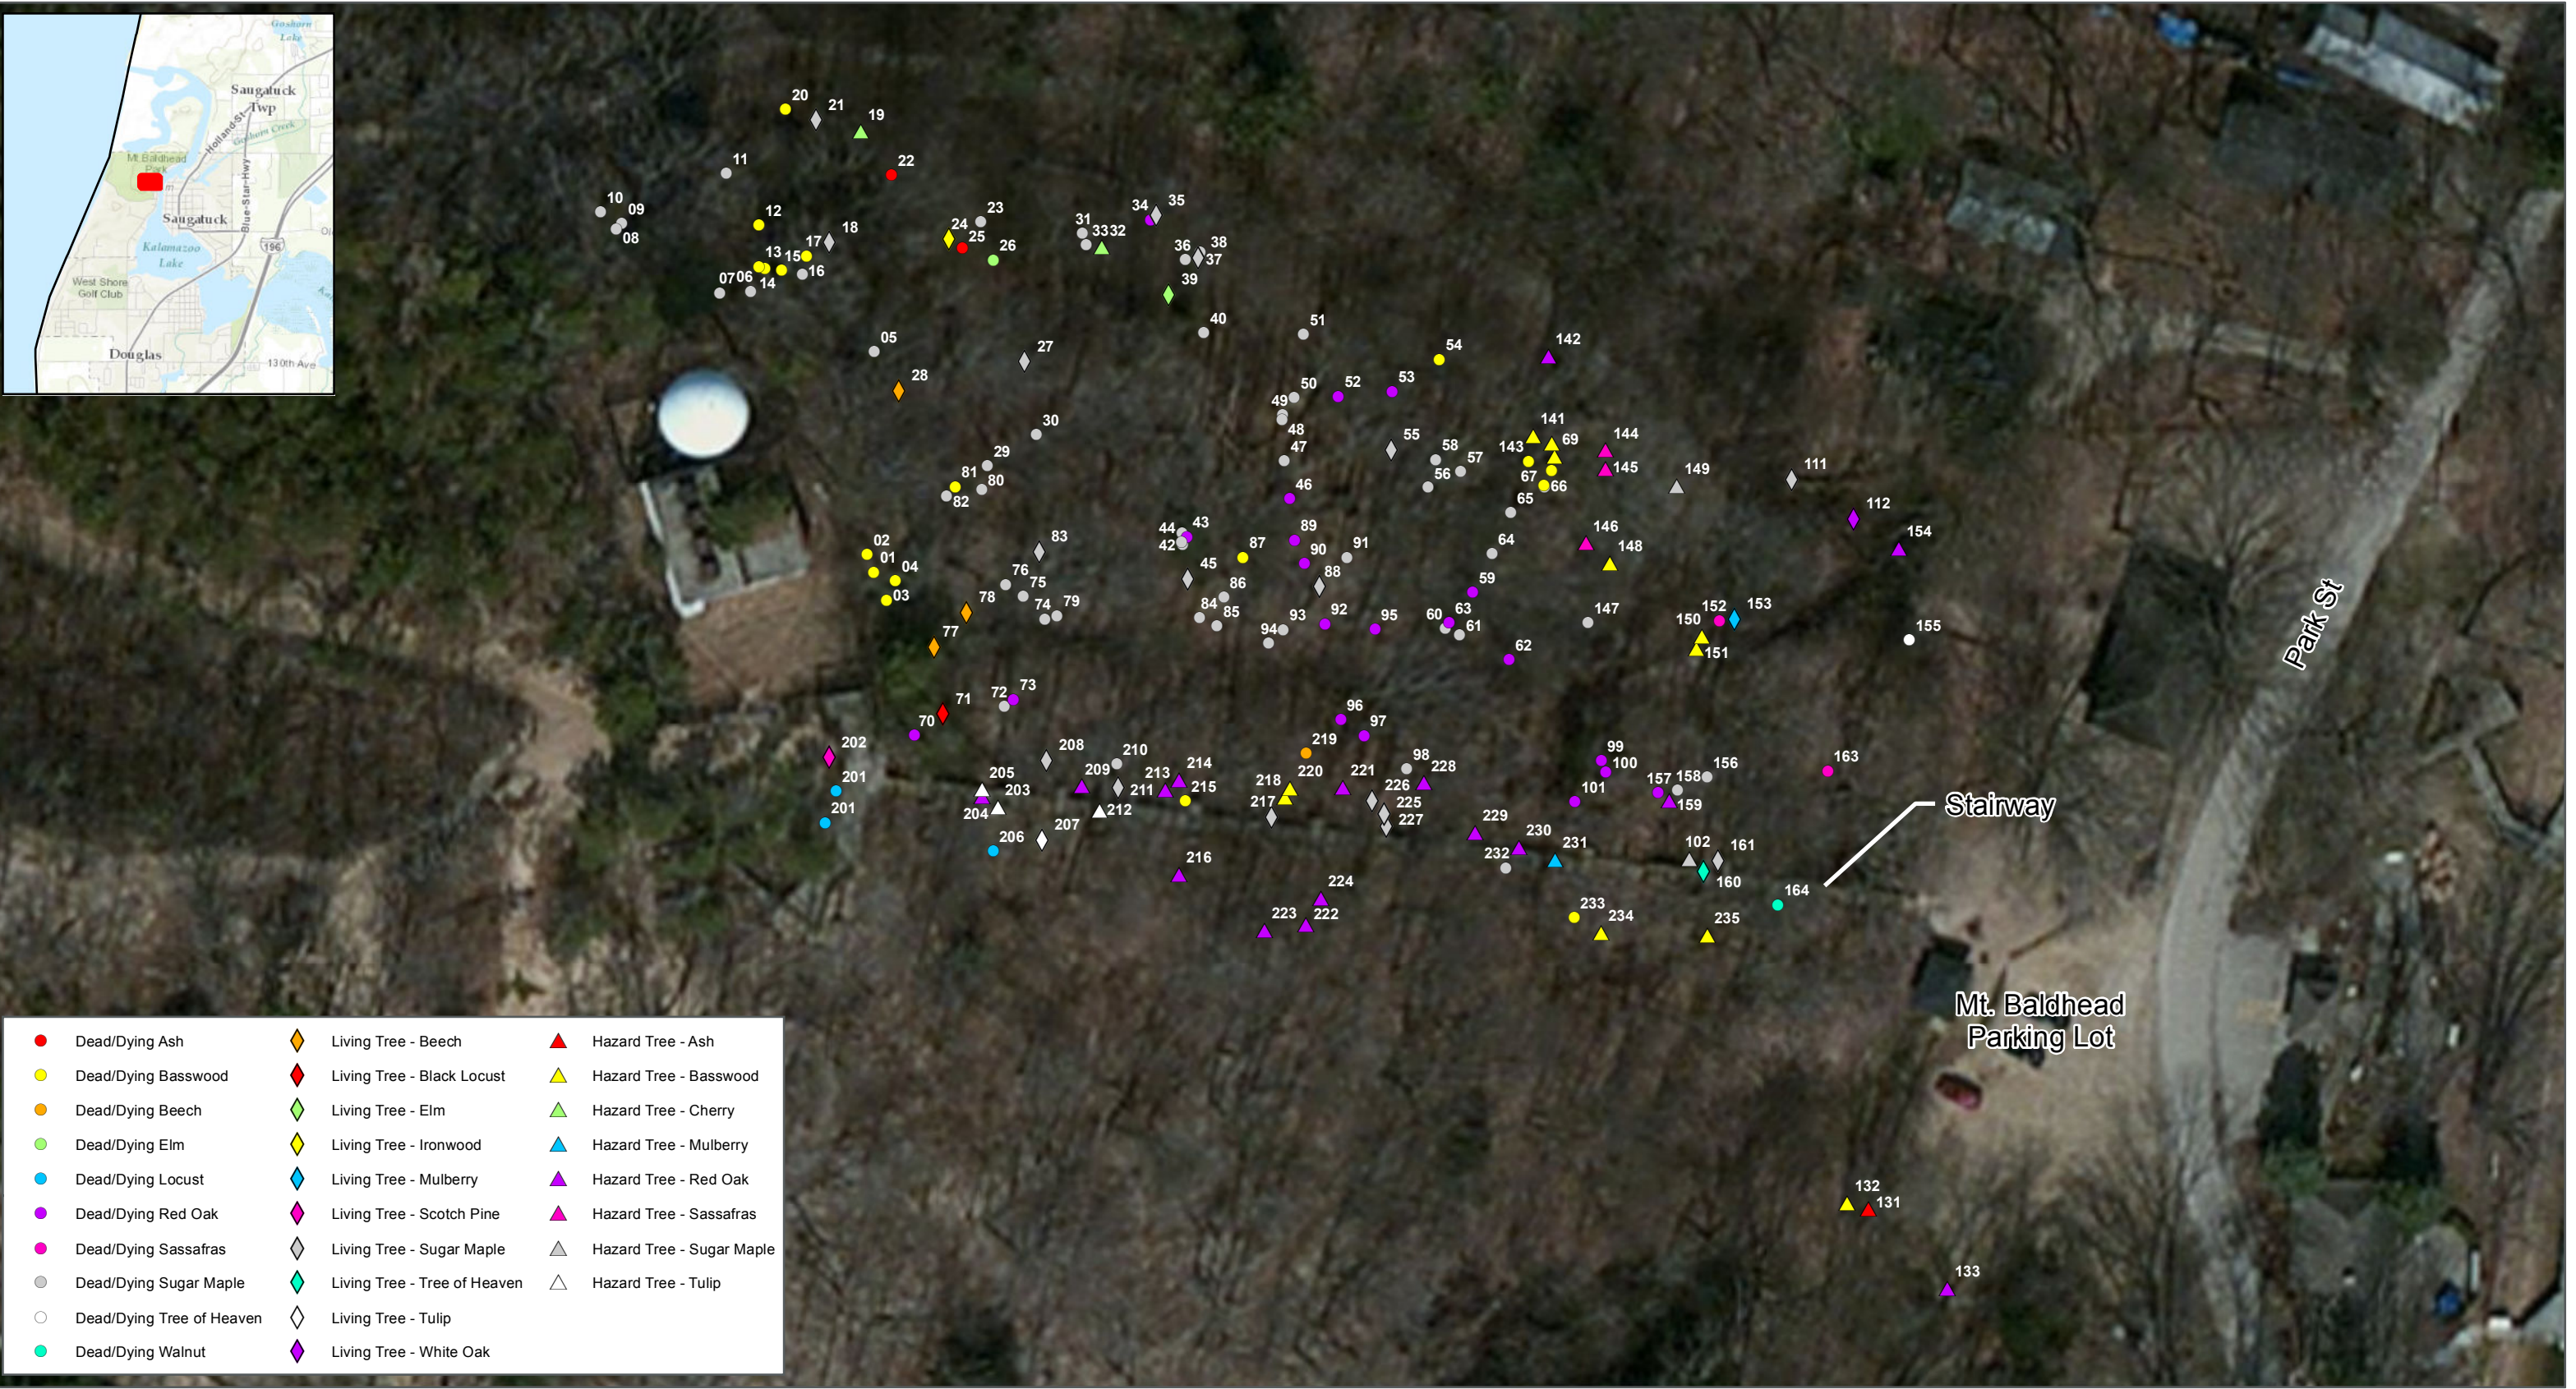
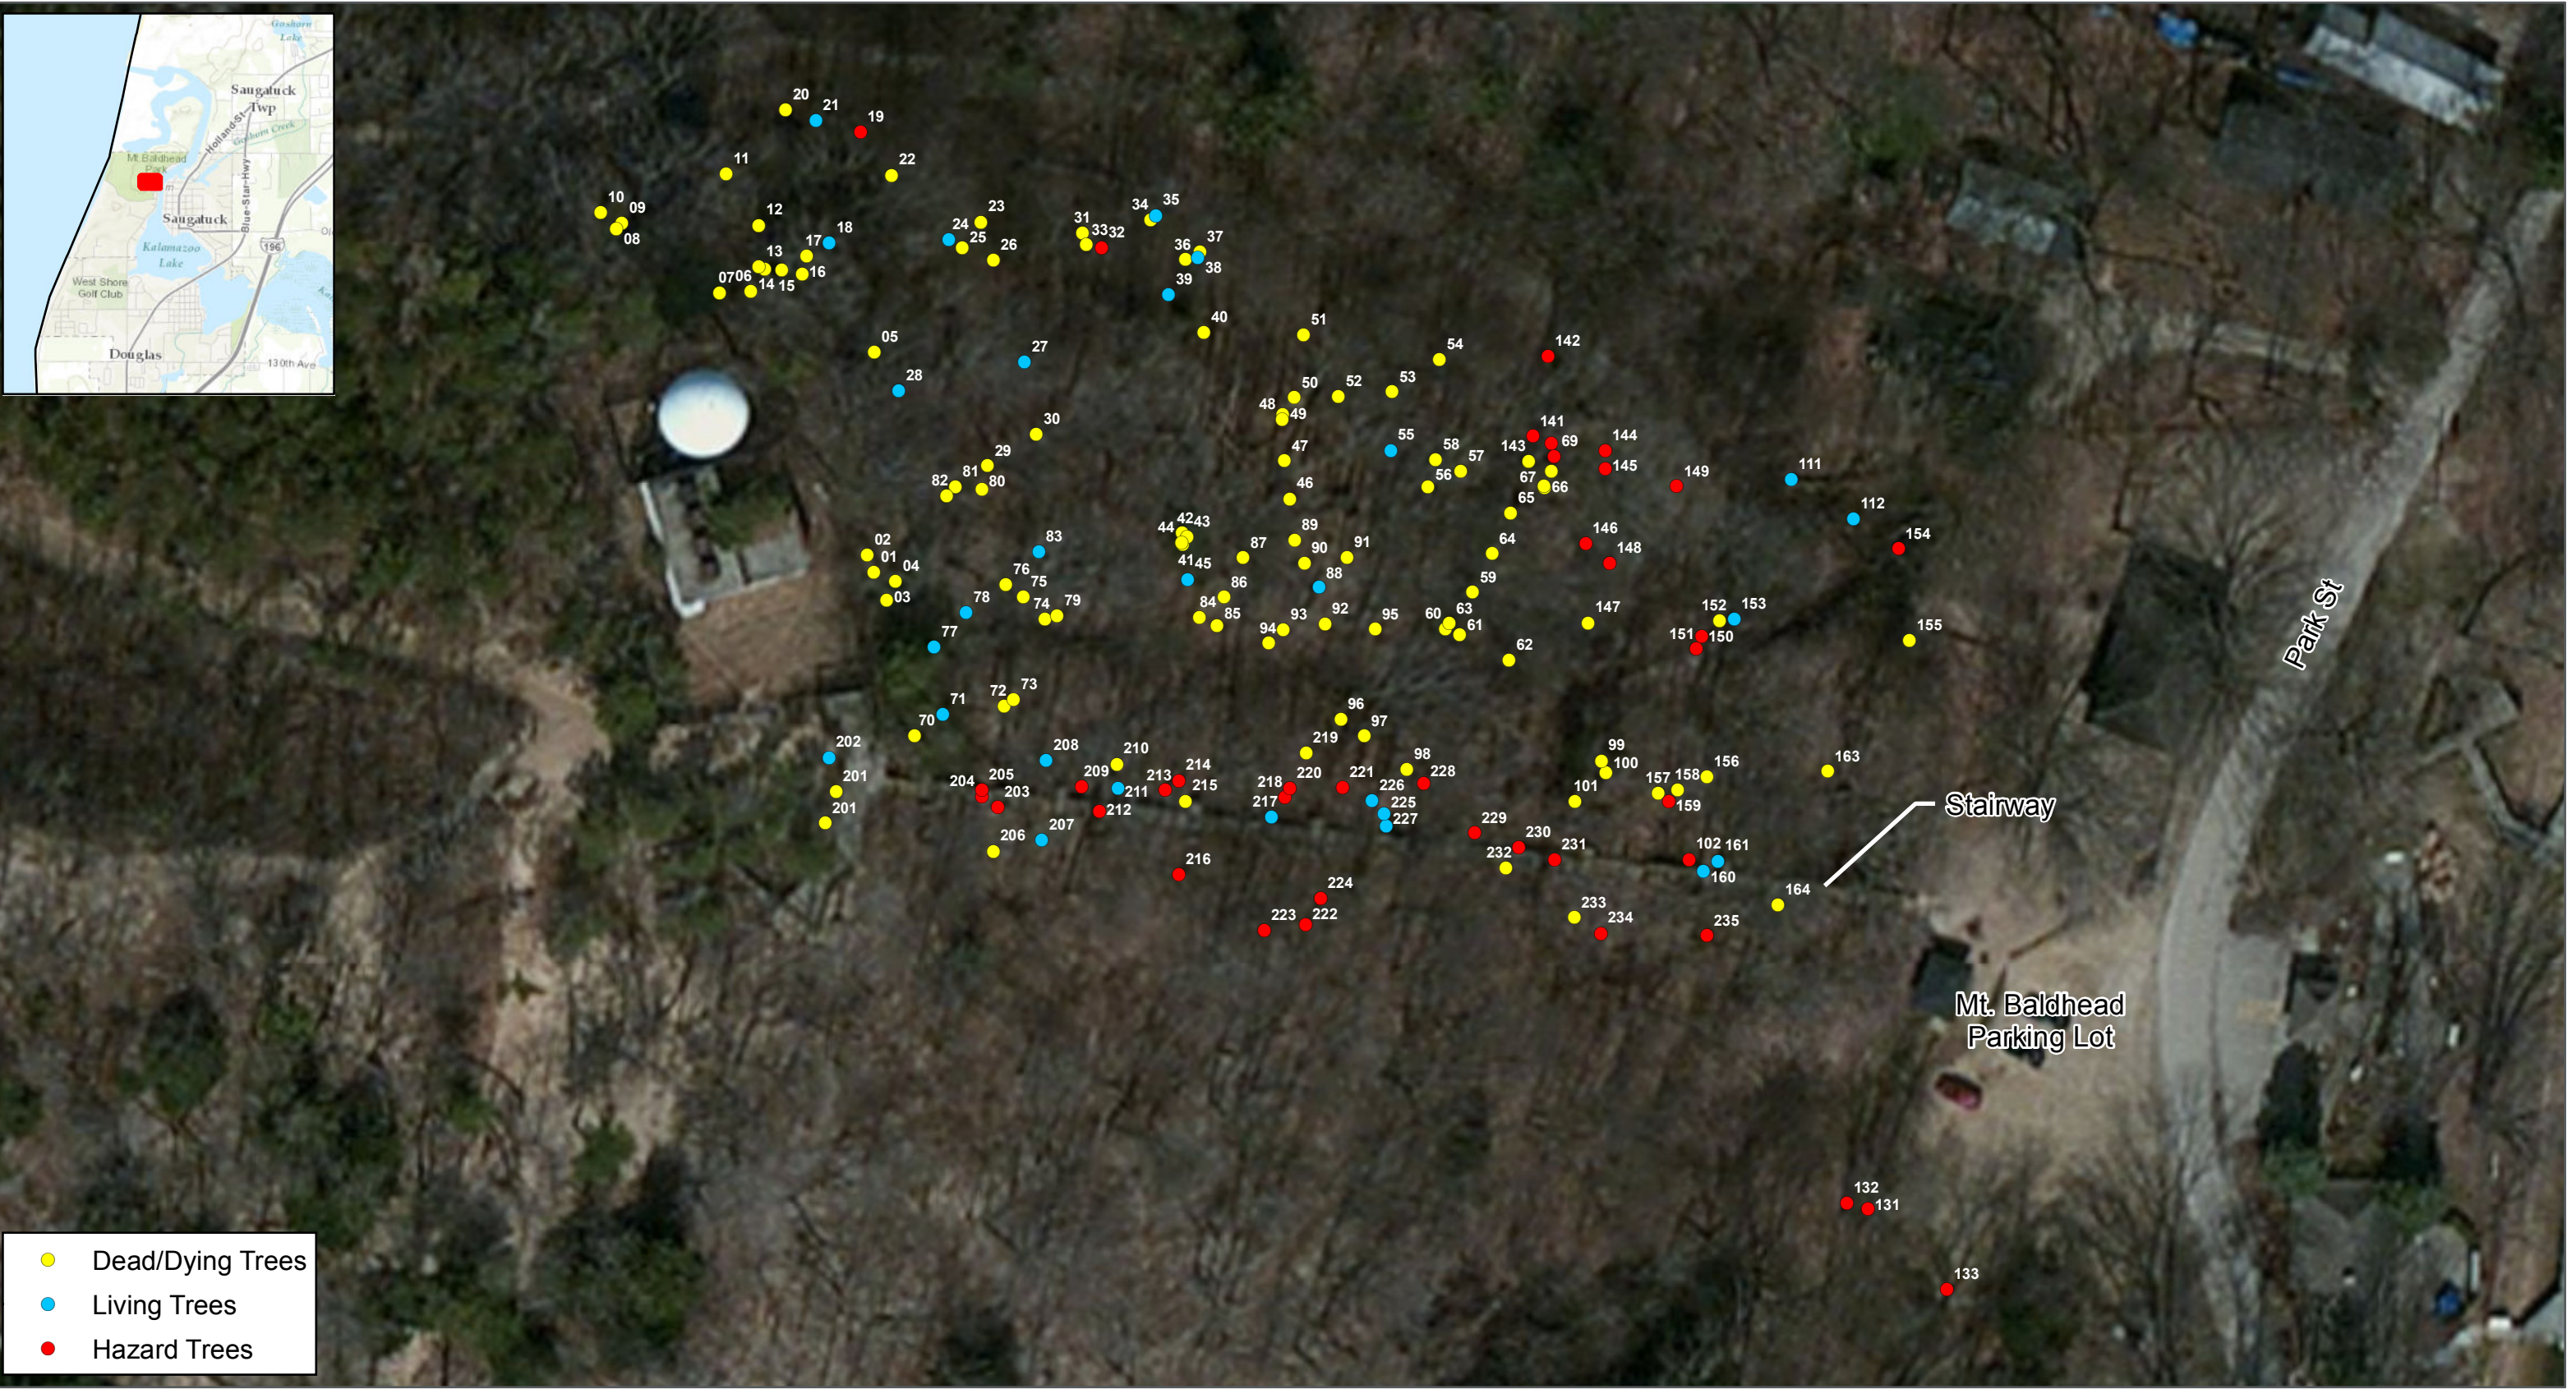
Figure 3 - Hazard Tree Locations  
Mt. Baldhead Site  
Land Conservancy of West Michigan  
Allegan County, Michigan

Of the 148 dead or dying trees, 42 trees (Figure 3) have been identified as hazard trees. A hazard tree is defined as any dead and/or damaged tree caused by the application(s)

of non-selective herbicides, where limbs and/or the whole tree has the potential to fall and reach park visitors using the stairway, foot paths, private homes, and/or the parking lot or pavilion area. For public safety reasons, all hazard trees should be removed and the wood and brush scattered throughout the site, as described below.

- Dead/Dying Trees
- Living Trees
- Hazard Trees

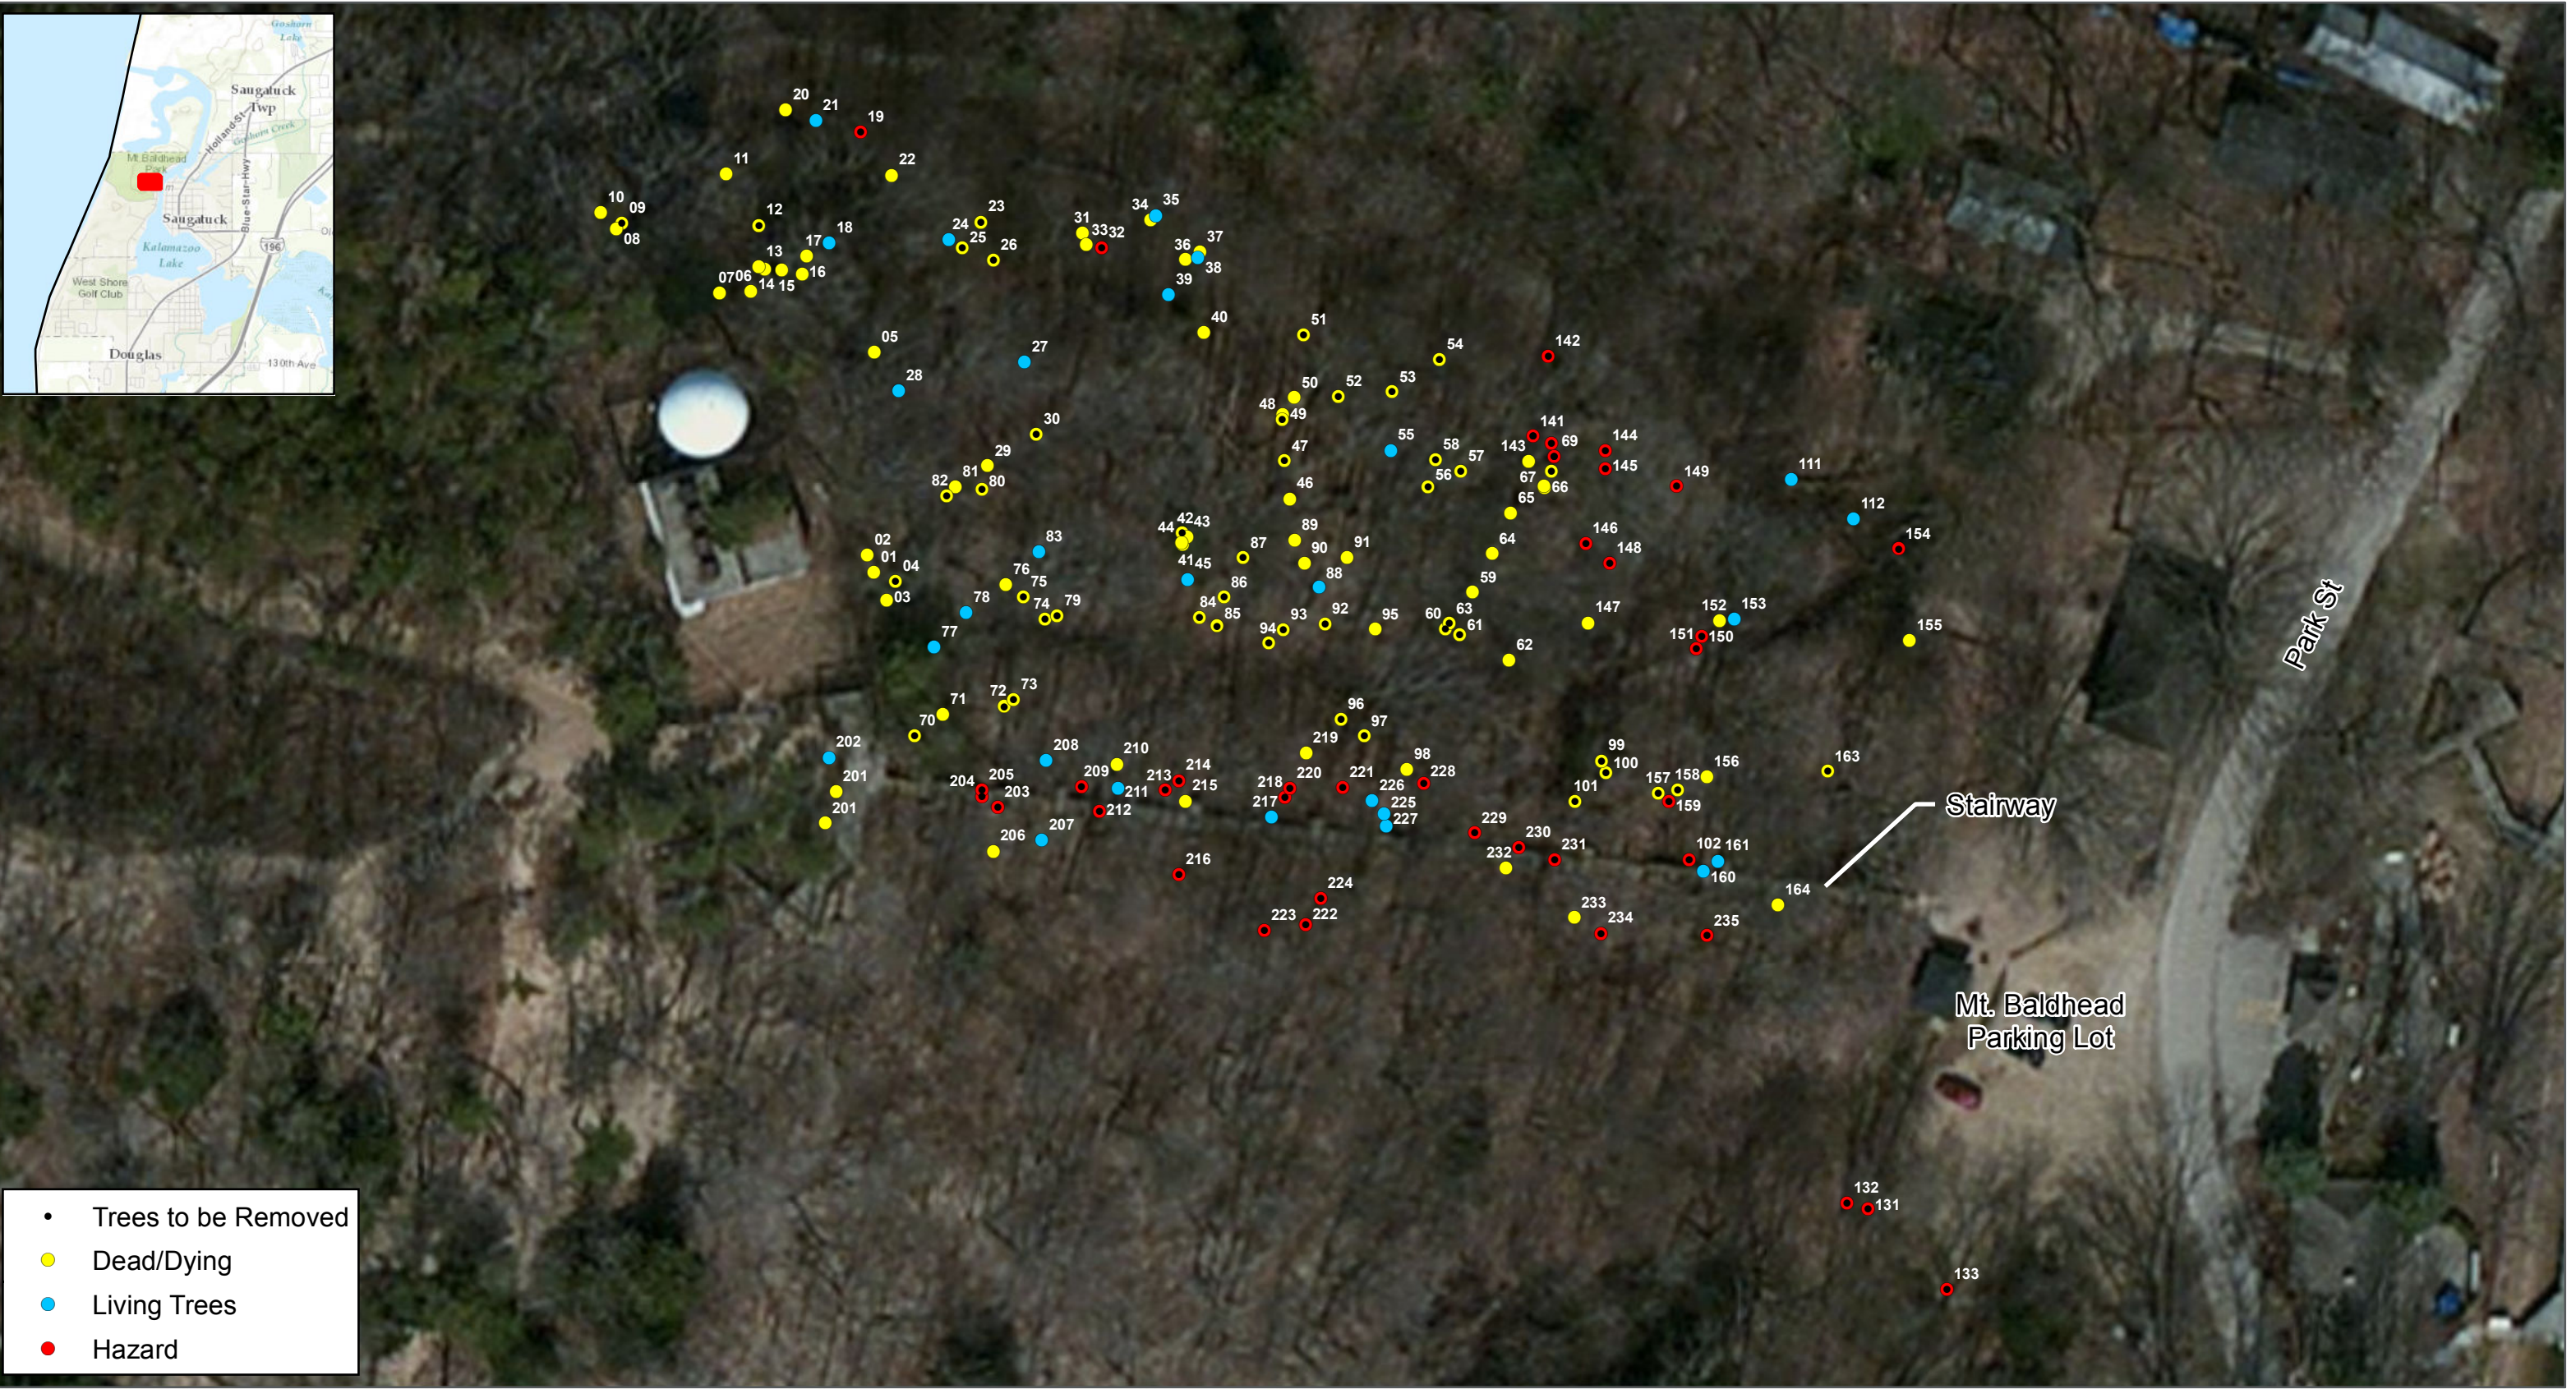
In addition to the 42 hazard trees, an additional 45 trees should be removed to reduce potential soil erosion that could be caused by wind throw and to encourage the re-establishment of the native ecological community.

- Trees to be Removed
- Dead/Dying
- Living Trees
- Hazard

Scattering tree trunks and crowns throughout the site will re-introduce detritus to the system, provide microbial habitat and also serve to stabilize the soil. The remaining dead trees should be left standing in place for wildlife habitat.

Removal of dead or dying trees shall be treated in one of two ways. They will either be left standing in place or they will be cut and scattered in appropriate locations for the reasons described above. Trees will be cut by the safest and most practical means necessary. Stumps will be cut flush to grade. Wood and brush will be spread throughout bare or open areas so as not to form “heaps” or piles. Tree crowns will be cut small enough to lay on the hill so that no portion extends more than four feet vertically from the ground surface. All cut material will be placed on the hillside in a manner that mimics natural detritus and minimizes erosion—cut material will not be placed in a manner that exacerbates erosion in any way.
